OFFICE OF THE CHIEF ENGINEER (Q.C.)
DELHI DEVELOPMENT AUTHORITY

Circular No 21

Subject: Quality Control - use of lime in masonry.

Compiled by - DDA Engineers Welfare Council

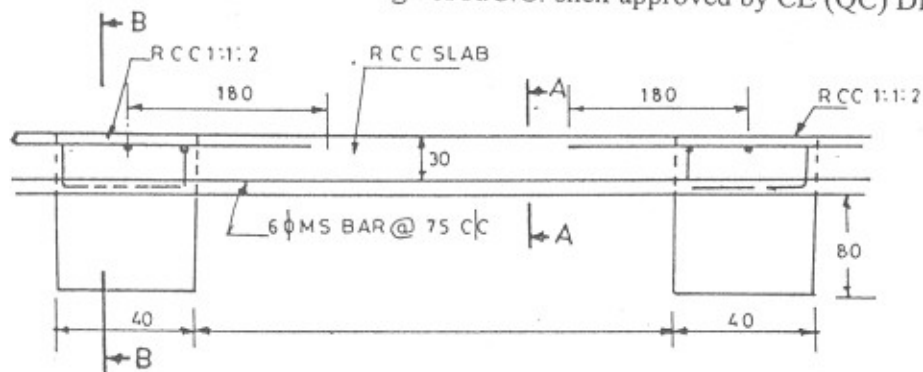
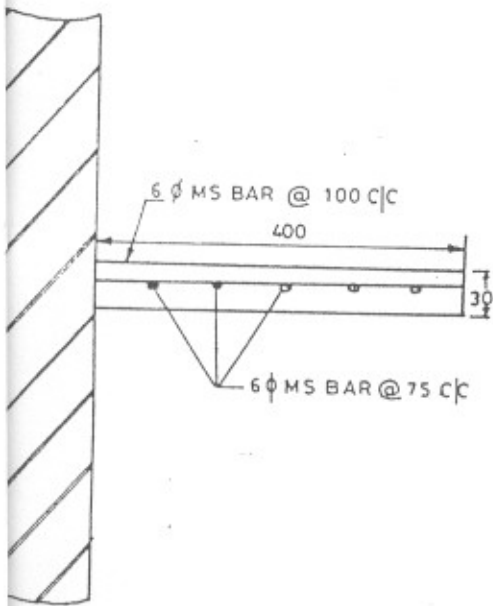
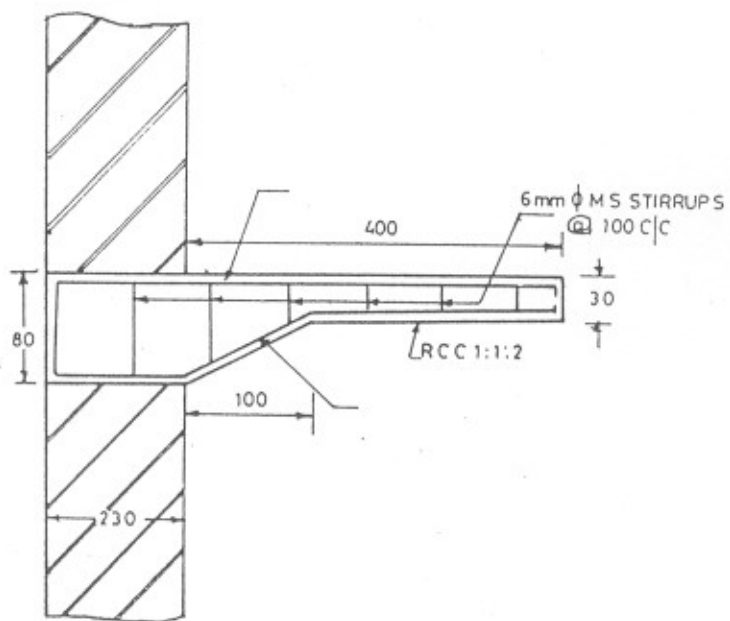
STRUCTURAL DRG.
R.C.C. SHELF.

The Fact Finding Committee appointed by the L.G. and the Committee which inquired into the Vikaspuri collapse have strongly recommended that no horizontal chases should be allowed in bearing masonry walls.

In the case of the cooking platform, it can be supported on half brick walls resting on the floor slab.

Other shelves should be supported on R.C.C. brackets or T-iron brackets enclosed into the wall in holes not exceeding one header brick,. A similar arrangement can be worked out with T-iron brackets.

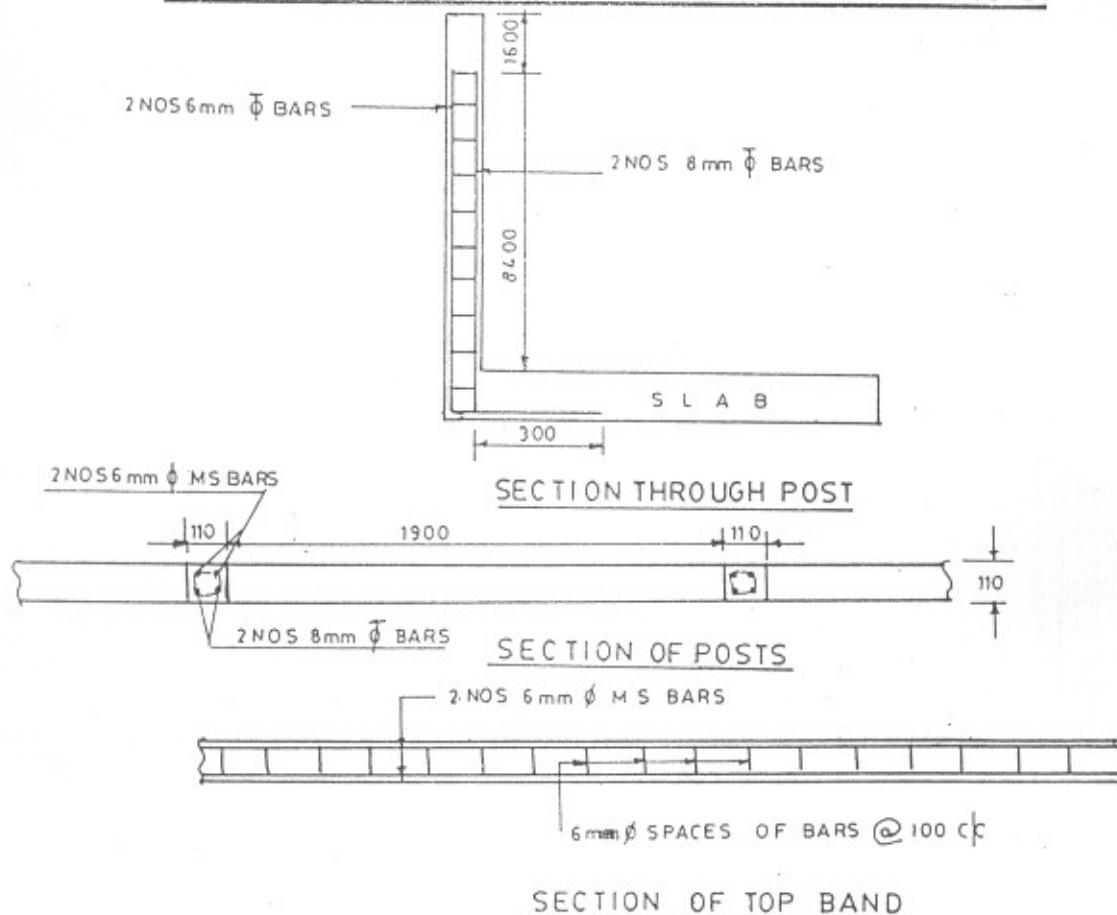
110mm THICK RB PARAPET WALL FOR BALCONY AND ROOFS.

Very often it is seen that half Brick or brick on edge parapet walls are provided for staircases, balconies and roofs which are source of danger to the lives of occupants & which are unsafe when checked under I.S. Codes. A drawing is enclosed herewith of a Half Brick parapet wall reinforced with horizontal bands & verticals posts. Brick-on-edge parapet walls should not be used at all & $\frac{1}{2}$ brick parapet walls should be reinforced as shown in drawing. Reinforcement for verticle posts should be preplanned & embedded in supporting slab. The concrete should be of C.C. 1:2:4 mixed with measuring boxes in the specified Ratio.

Very often it is seen that half-brick ✓
or brick-on-edge parapet walls are provided
for staircases, balconies and roofs which
are a source of danger to the lines of the
occupants and which are unsafe when checked
under the I.S. Codes.
